## A Report on Conditions and Monitoring at the J.K. Williams Flagpole and Monument

In July 2015 Frank Briscoe with Briscoe Architectural Conservation (BAC) participated in a study of conditions at the flagpole and monument immediately east of the J.K. Williams building.

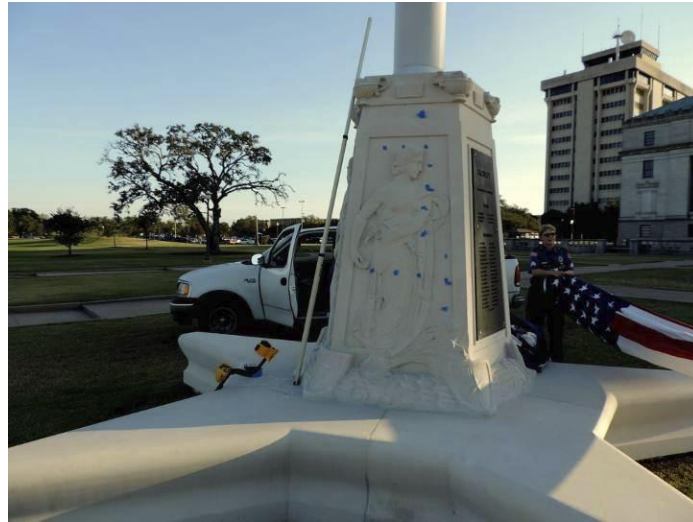
Monument during determination of rebar locations.

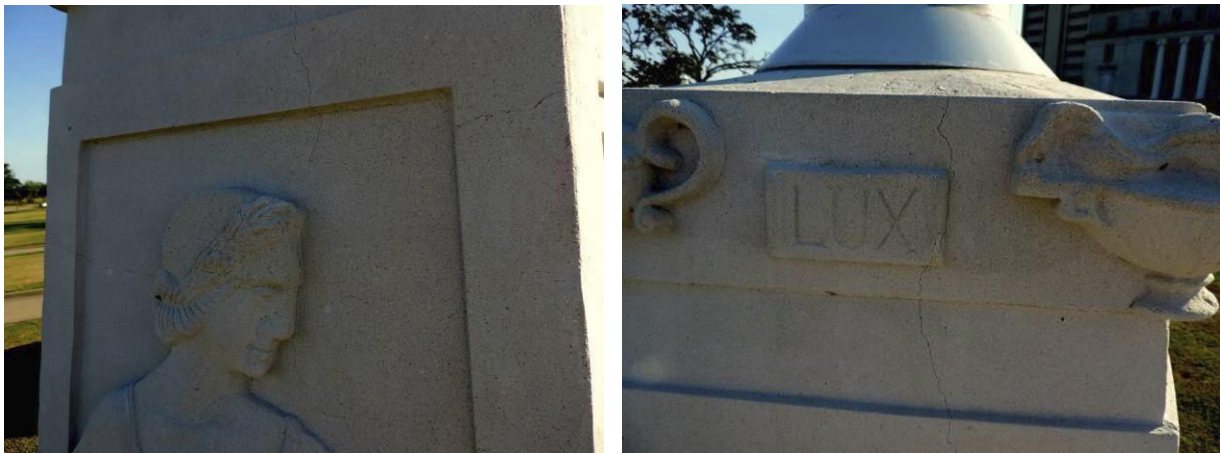
Increases in fractures, in size and width was noticed during September monitoring. Rebar placement strongly coincides with fracture locations, but is unlikely to have contributed to the fracturing. According to the fabricator, rebar within 2” of the surface was coated with epoxy before installation, and is therefore unlikely to have corroded and be the cause of the fractures. Even if not coated, corrosion would take longer and manifest itself less evenly than in the pattern of fractures that exists.

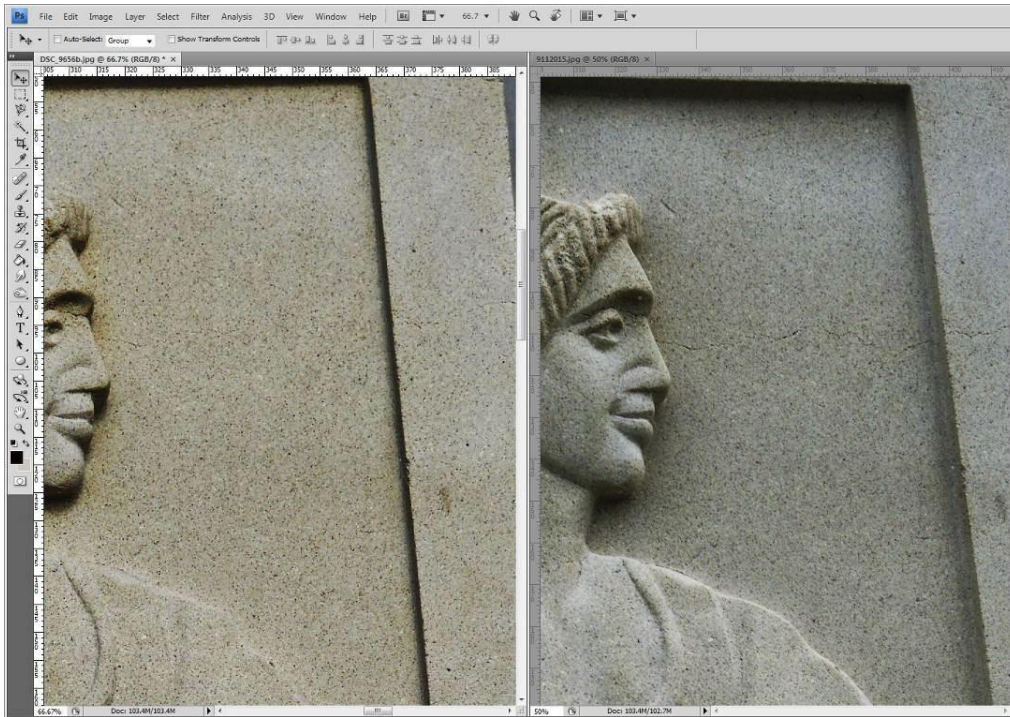
Monitoring by Center for Heritage Conservation: July 2015 (L), and Sept 2015 (R).

Between July and September 2015, what had been visible, but fine, fractures erupted into conspicuous cracks belting the monument along with new strongly vertical ones. The vertical fractures continue over the upper surface and a few inches down into the mortise. In three of four cases they pass through the patches at the anchorage points from which the monument was lowered during installation.

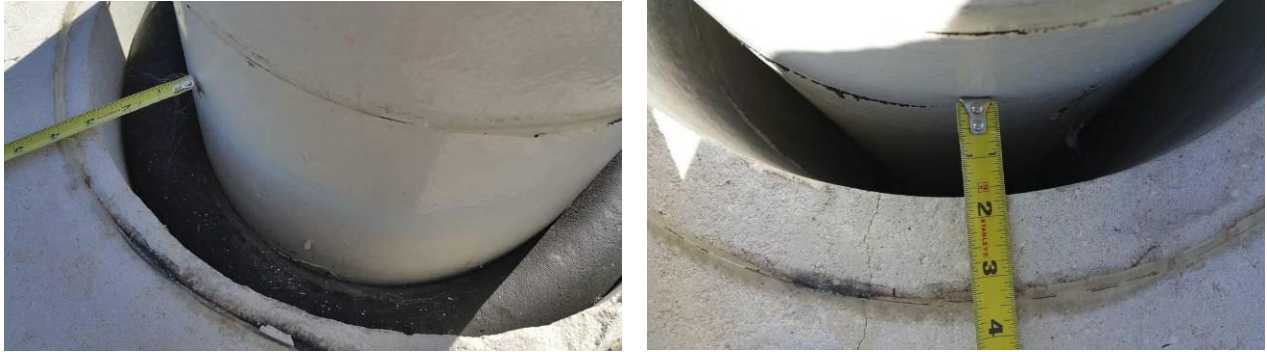
When the collar was removed it could be seen that the upper edge of the mortise was chipped in places, with small fragments of the monument sprinkled over the backer rod. It is possible this is from the collar scraping the top surface, as even slight breezes are enough to move the collar perceptibly. The monument is not centered on the flagpole, but about 1/2" toward the south from center. The distance from the north edge of the mortise to the pole is about 2-3/4"; from the south about 1-5/8"; and about 2" from the east and west sides.

The space between flagpole and mortise is 2-3/4" on the north side (L) and 1-5/8" on the south side (R). On the east and west it is almost even.

A thick, soft backer rod is stuffed into the mortise, circling the flagpole. When removed, it was found to be dripping wet, although it had not rained in a few days. The purpose of the backer rod seems to be to exclude moisture and perhaps debris from the mortise. In practice, it is trapping water and decreasing the amount of play the flagpole has before it begins to exert pressure against the side of the mortise. Although it is very soft, once it is compressed to about 1/2", it resists much further compression.

remedied at very little cost – removal of the backer rod, and replacement of the flags currently in use with lighter, nylon ones. It is conceivable that these actions alone will prevent any additional fractures.

- review scans of the original and make any corrections to the model as necessary for accuracy;
- install vented collar;
- replace thick backer rod with screen;
- increase the diameter of the mortise to reduce chance of flagpole contact with top of monument, based on monitoring of movement of the collar;
- introduce weep holes, descending from intersection of flagpole with base, and create positive drainage from flagpole base toward weep holes so that no water will be standing in contact with flagpole.
