Historic Resources Assessment  
Rancho La Union, Zapata County, Texas

for the Guadalupe and Lila Martinez Foundation

FRANK BRISCOE / Architectural Conservation

December 2009

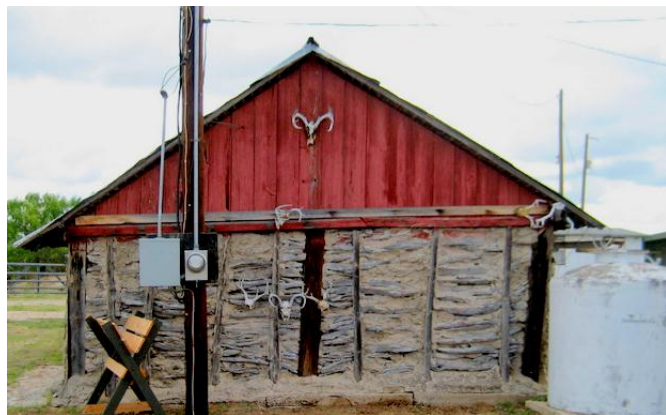
figure 11. west façade of Bunkhouse

All posts visible at the exterior are mesquite with the exception of those along the west wall (fig.11) and one post where the *jacal* portion intersects the later addition on the north side (fig.12). The mesquite members are either un-worked or show a minimum of shaping, and some were installed with bark attached. The west wall has been largely – or completely – reconstructed. Original northwest and southwest corners have been

replaced with heavy dimensional members similar to railroad ties, and a like member has been added at the center of that wall. Other west wall posts are cedar. The west gable, unlike the east gable of the *jacal* portion, has been rebuilt with vertical plank siding.

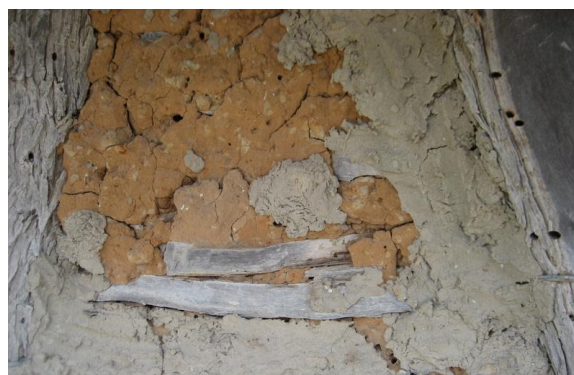
figure 14. early reddish and tan plasters below cement

Both interior and exterior wall surfaces have been plastered with mud plaster. There have been at least three applications of plasters, but the original, innermost mud material is distinct for its deep reddish color (fig.14). The outermost layer, added as a repair in several portions of the interior and exterior, is a strong cement plaster. Exterior plaster shows

extensive erosion and a majority of the wood structure and wall infill is exposed.

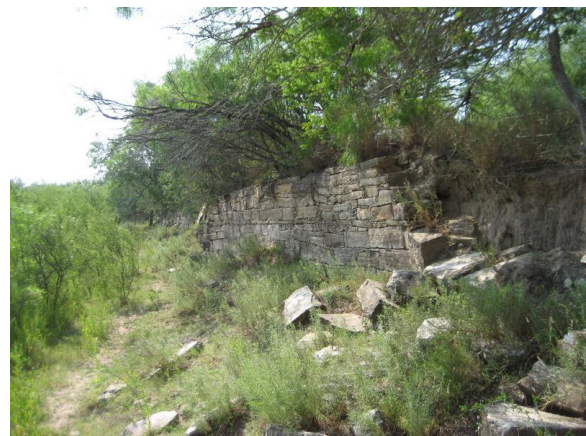
figure 25. tallest section of the dam, about 7'6"

The most intact part of the stone work is a +/- 45' section about 40' east of west end. At 7' 6", this is also the tallest intact, visible, section of the masonry. Like most of the structure, it is being pried apart by tree roots, and possibly by hydrostatic pressure from the earth behind it. This section of wall is approximately 15" out of plumb, leaning outwards from the top.

Recommendations for preservation include stabilization of all or part of the section of the dam described above. The budget estimate below includes the entire 45' section. With some variations, the stabilization actions could be implemented as part of a masonry conservation program in an educational environment. If the stabilization actions are carried out over a period of years, or if no action will be taken in the near future, a simple buttress can be constructed to prevent the tall section from further dislocation.

The first step in stabilization of sections of the structure will involve removal of deep-rooted plants in the immediate area of the section of dam, making sure that stumps of plants cut down are treated with an herbicide that will prevent their return. Roundup™ or one of its derivatives work well but must be used promptly after cutting the plant. Typically a concentrated mix of the herbicide is brushed onto the stump. Care must be taken to prevent it from getting in the ponds because it is hazardous to amphibians.

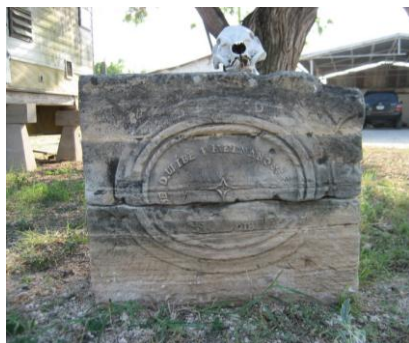
figure 28. Stone marker

Near the center of the complex is an inscribed stone marker (fig.28). The stone is approximately 32" high, 36" wide, and about 10" deep. In a script reminiscent of the mid-Nineteenth Century are raised letters " \_\_SE D. URIBE Y HERMANO J<sup>E</sup>" arranged along the inside of the upper half of a horizontal medallion shape. Other letters or words on the bottom half of the medallion are illegible.

Other than lifting the stone from ground contact, the only other recommendation would be consolidation with ethyl silicates in a treatment similar to what is recommended for localized consolidation of early earth plasters.

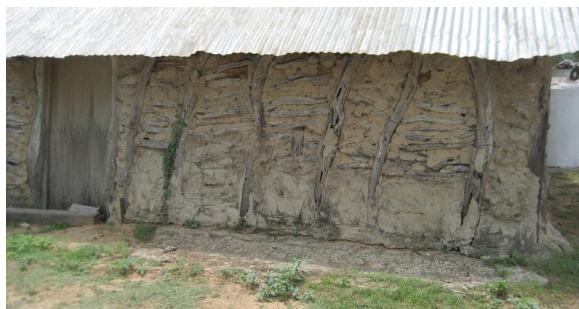
figure 29. cement plaster at wall base near northwest corner

The wall and gable at the west end of the building were probably replaced due to structural failure along that façade (possibly related to prior elements of a water collection system). Adjacent posts near the northwest and southwest corners were left in place, although some of the problems that made the repairs necessary are likely here, too. Some wood posts at these locations show deterioration at their connections with the slab. Even in dry climates, slabs and other masonry materials retain moisture for long periods of time, and this creates an environment for decay fungi and termite attack on wood materials close by.

At some point after replacing the west wall, repairs were made with a cement plaster that is trapping moisture against the earlier plaster and mesquite members. It is recommended that portions of this plaster be removed along the north and south sides near the west end, especially as necessary to make visual inspections and/or repairs of the post bases there (fig.29).

If decay at post bases is found to be minor, cement plaster removal can be minimized unless a restoration of the structure is pursued.

Post bases should be carefully probed with a sharp object to determine extent of decay. If mesquite post bases show deterioration through more than one half of the cross section of the member near the base, it will be

necessary to saw out the deteriorated lower area of the wood member and create a durable structural joint with similar replacement material. Alternatively, if a mesquite member matching the damaged one can be located or fabricated, it may be possible to sensitively replace the entire member.

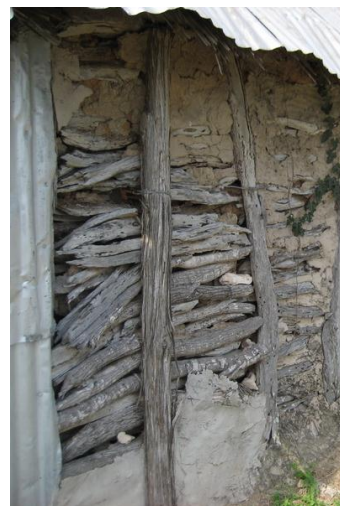
figure 30. non-original section

The northeast corner of the *jaca* portion where it intersects the corrugated-sided addition to the east has been replaced on the exterior surface (fig.30). Almost all early exterior plaster in this area is either lost or replaced with cement plaster. Lower infill on the exterior side of the wall appears to be a fairly recent replacement. The interior surface at this location appears to retain its early plasters, and therefore at least part of the original mesquite infill. Care should be taken to avoid disturbing inner wall material during repairs to the exterior.

The recent cement plaster should be removed from the lower wall base. Recently installed wall infill members could be replaced with more sympathetic materials. The cedar post at this location could likewise be

replaced with a mesquite member during these repairs. Following the wood replacement the area should be treated with Bora-Care.
