Fleming Ranch Drainage Considerations

Fleming Ranch Drainage Considerations, 2012.

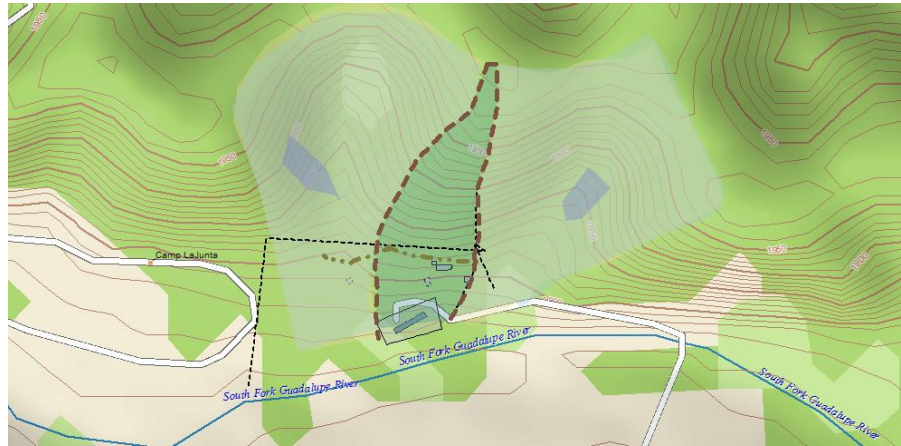
The main house and outbuildings are located on a gently sloping terrace between the South Fork of the Guadalupe River and a zigzagging formation rising to the east (figures 1–3). The part of this formation affecting the drainage of the area immediately surrounding the main house is roughly in the shape of a “W” turned on its side (i.e., north–south), with the main house approximately opposite the central vertices.

figure 1. 2-D view of house site drainage basin (darker area) and basins to the north and south.

By drawing a polygon from the area of the main house site (including about 50' to the north and south) uphill to the peak at roughly right angles to contour lines, a watershed of approximately 6 acres is enclosed. Using similar methods, the areas to the immediate north and south of the house site include drainage areas of more than 20 acres and 15 acres respectively.

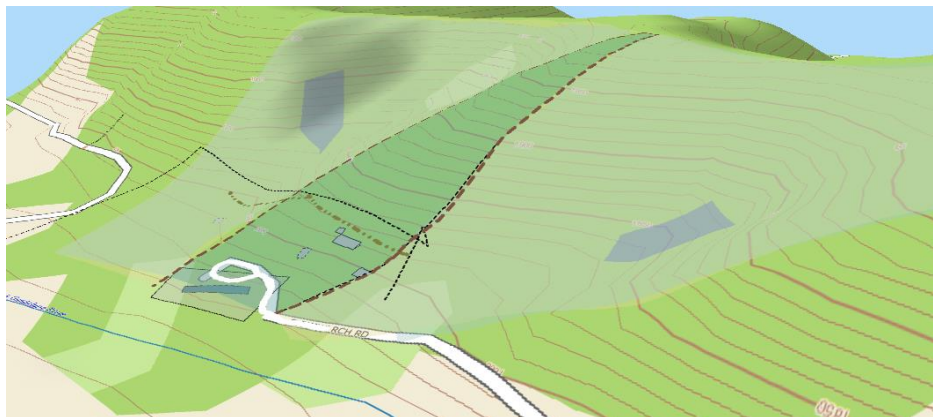
figure 2. 3-D view of site and hillside above from south. (blue arrows indicate potential drain paths during intense rain)

From review of 3-D topographic maps, it appears that during especially heavy rain events, runoff may be descending from the northeast with such velocity that it may enter the drainage basin of the main house. Mainly this would seem to come from the steep, south slope of the hill to the north of the knoll in front of the main house. The Maid's house seems to be in the line of the potential current, so if there has never been damage to this building or substantial scouring of the soil around it from runoff originating from the northeast, corrective action may not be necessary.

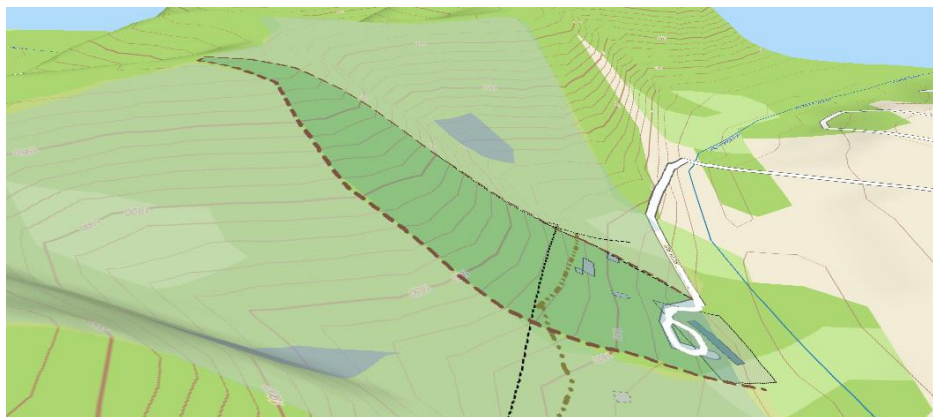
figure 3. 3-D view of site from north.

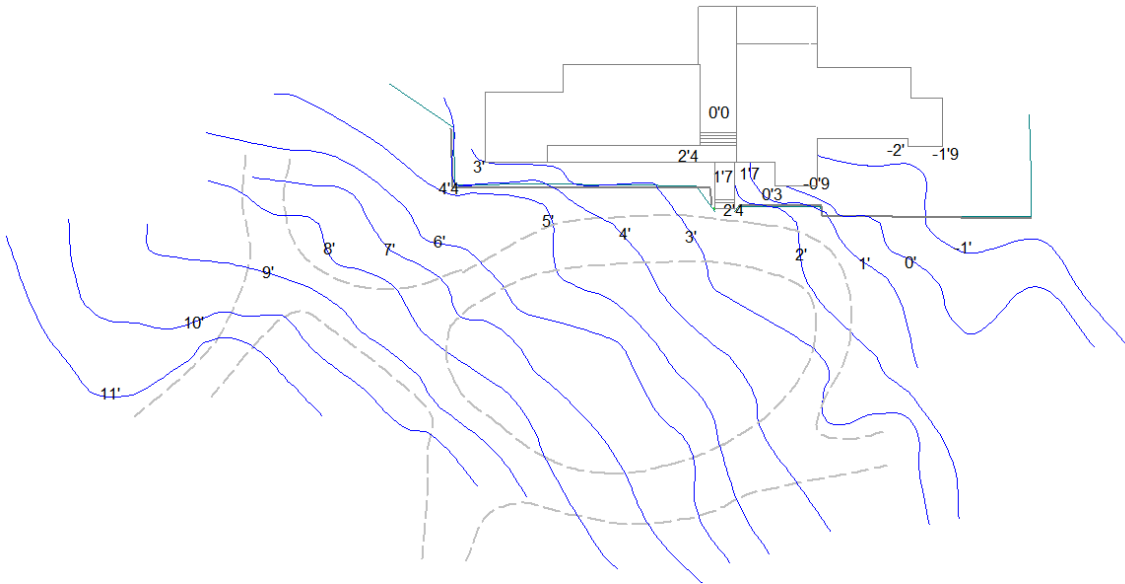
Additionally, conditions in the immediate surroundings of the main house make it vulnerable to damage by heavy rains. Gutters and downspouts at the east side of the north wing must convey large quantities of water away from this area to avoid exacerbating the problem, and grades between the retaining wall and the house seem to be guiding runoff toward the northeast corner of the building.

The elevation of the terrace on which the main house and outbuildings sit is between about 1776’ and 1800’ above sea level, while the peaks of the formation to the east are at about 1990’. Contours of the terrace show a strong north–south orientation, while the long axis of the house is northwest–southeast (figure 4). As the terrace/driveway area immediately in front of the house drops more than 10 feet across the east façade, from south to north, any runoff that makes its way to the house must pass along the northeast corner of the building. The west side of the house is unaffected by drainage issues.

It is about a quarter of a mile from the main house to the peak of the center area of the “W”. This center slope that descends to the house is significantly less steep than the walls of the valleys to the north and south, but still has considerable grades. Between the house and the far side of the driveway circle 150’ away, the grade is from 8% to 12%. Fifty feet above the circle, which is at an elevation of about 1800’, the grade rises steeply from a 19% grade to a 26% grade at 1850’. This is significant because grade affects runoff rates and, relatedly, because the destructive power of runoff increases geometrically with its velocity.

figure 4. 1’ contours of the terrace east of main house, with 0’0” elevation at lower breezeway level.

Addition of 6–8" to the height of the retaining wall along the east side of the north wing is recommended, beginning at or near the entrance gate and continuing north to a point even with the north side of the sleeping porch. The object of this is to break the energy of – and divert – sheeting runoff approaching the house. It is not expected that this installation would be effective without the following recommendation for swale construction, which should reduce the amount of runoff reaching the house by 40–60%.

The area between the retaining wall and the house should be regraded where there is not positive drainage away from the house toward the wall. Mostly this will have to be done through cutting rather than filling because of threshold elevations at the laundry area and window sill elevations at the master bedroom. Earth removed in cutting could be used to provide positive drainage away from the wall toward the drive, but 4" to 6" of the stone should be exposed on the drive side.
