## The Orange Show – A Conservation Update

Prepared for **The Orange Show Center for Visionary Art**  
2402 Munger Street  
Houston, TX 77023

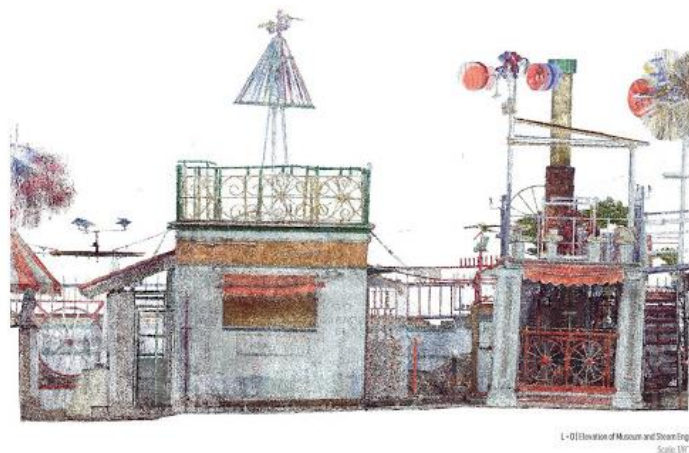
Figure 1. Museum and Steam Engine – south elevation.

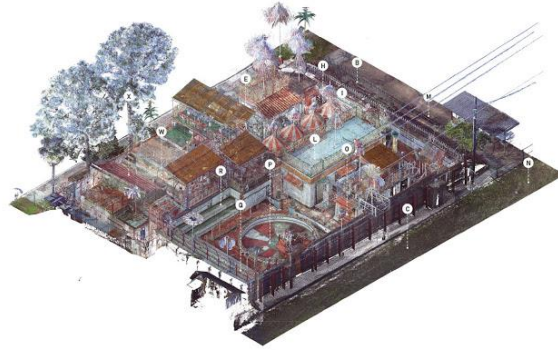
Figure 2. Perspective view of 3D model of *The Orange Show* (feature labels from SWCA plan).

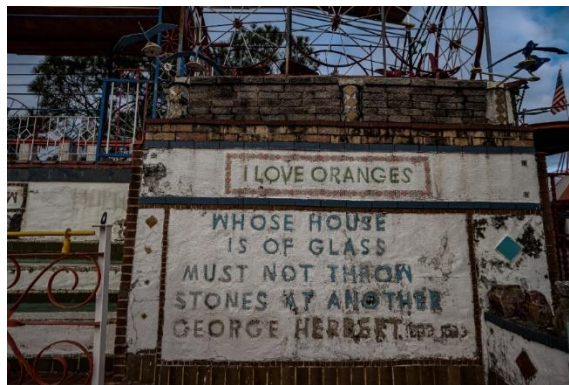
Figure 5. Mosaic at Amphitheater seating.

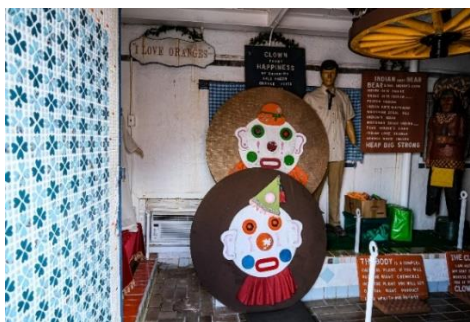
Figure 6. Entrance and artwork within The Orange Show museum.

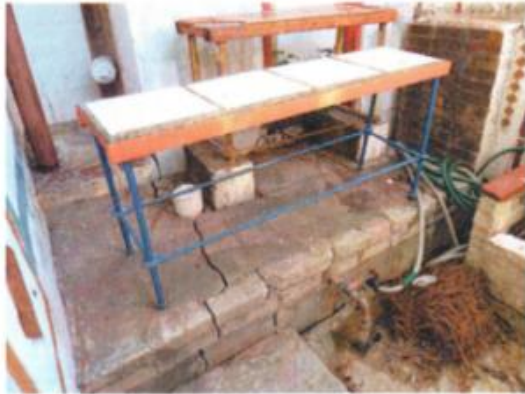
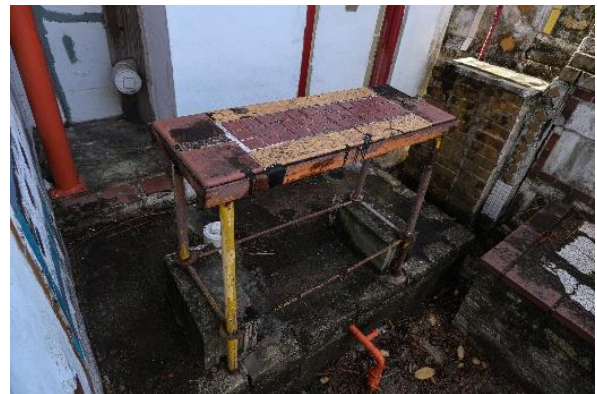
Figure 7. "A high level of foundation distress was observed at the northwest corner and is associated with the restroom plumbing." Sparks Engineering 2012 (left 2012, right 2021)

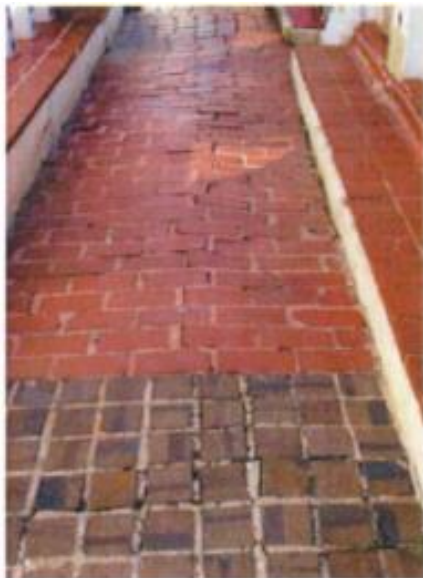
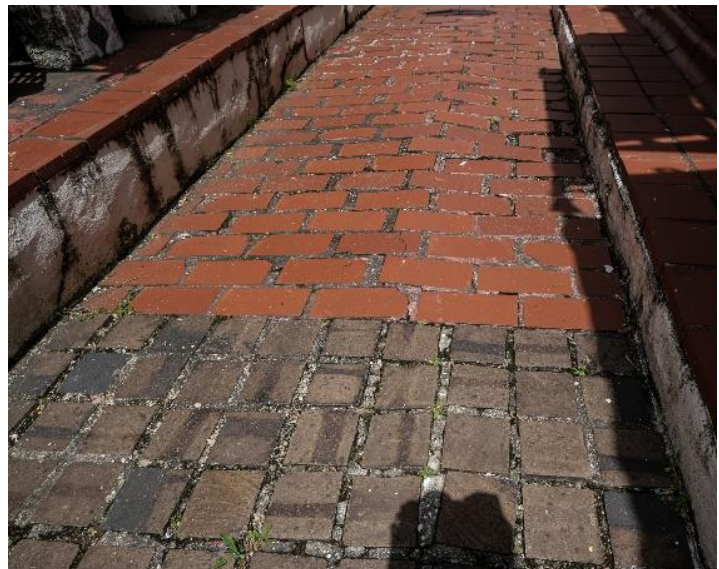
Figure 8. Walkways have heaved and settled throughout the facility, creating poor drainage and difficult walking conditions. (left 2012, right 2021)

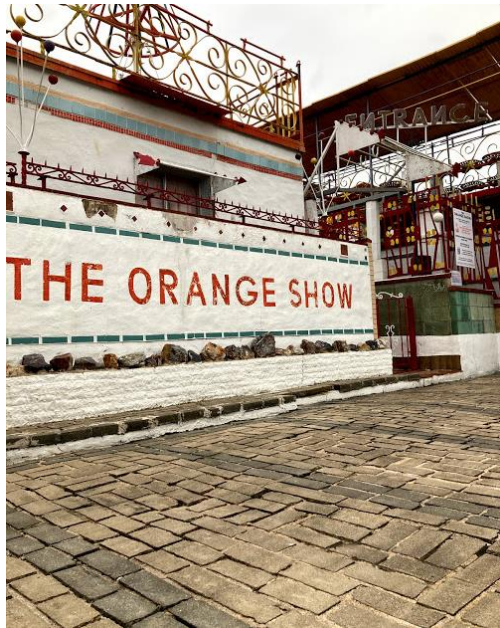
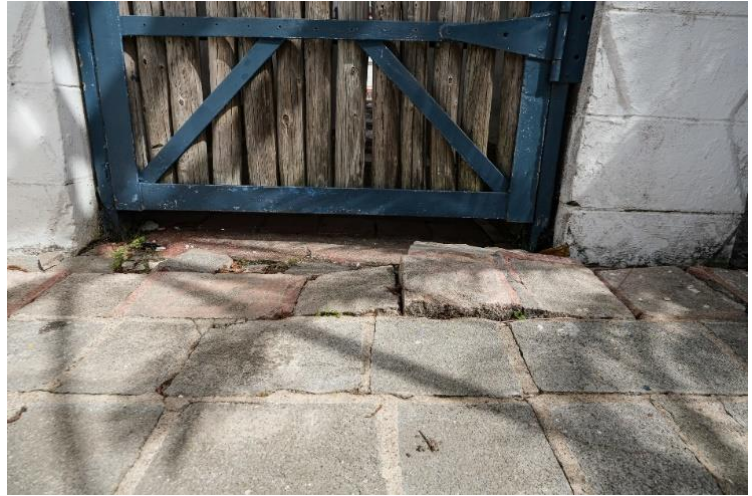
Figure 9. Additional examples of disrupted walkway surfaces.

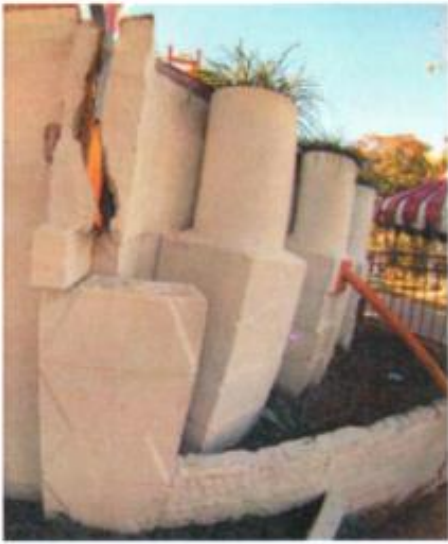
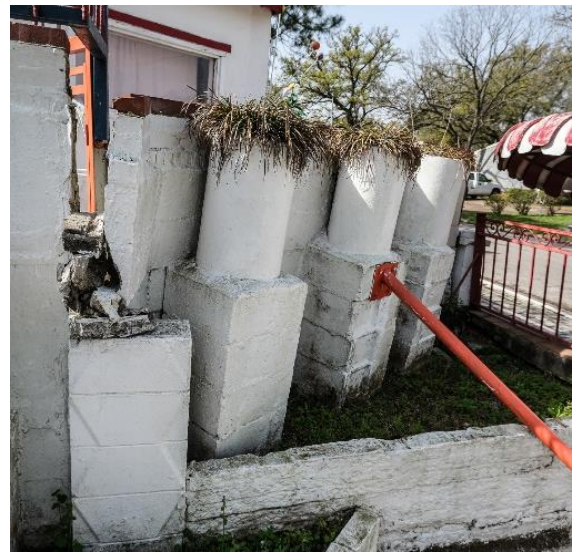
Figure 11. "The northeast [northwest] corner wall was braced in a previous repair campaign. Reconstruction with a new footing will be required." Sparks 2012 (left 2012, right 2021)

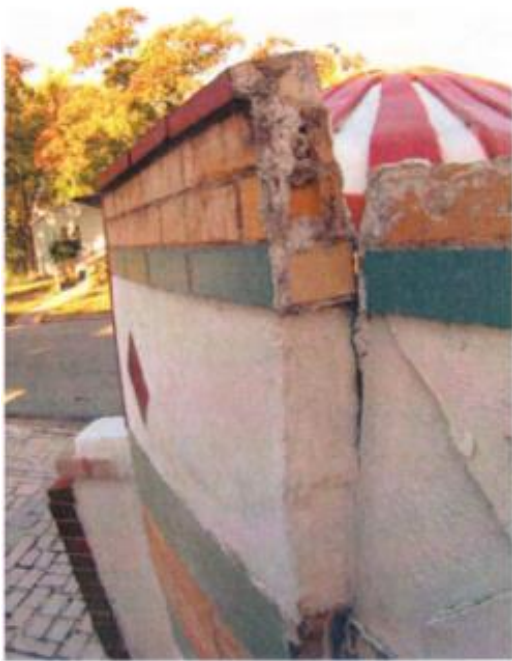
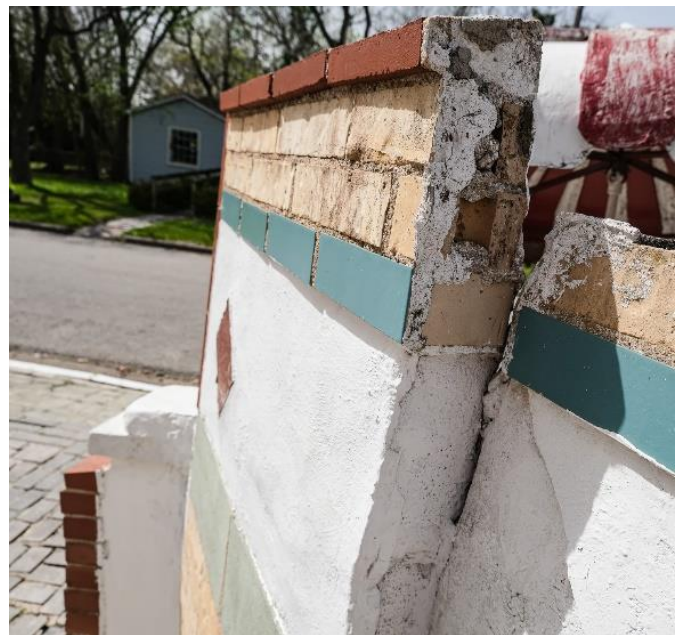
Figure 12. "A break in a single-wythe solid masonry wall without lateral reinforcement. Note that there is no bonding of the masonry courses across this joint." Sparks 2012 (left 2012, right 2021)

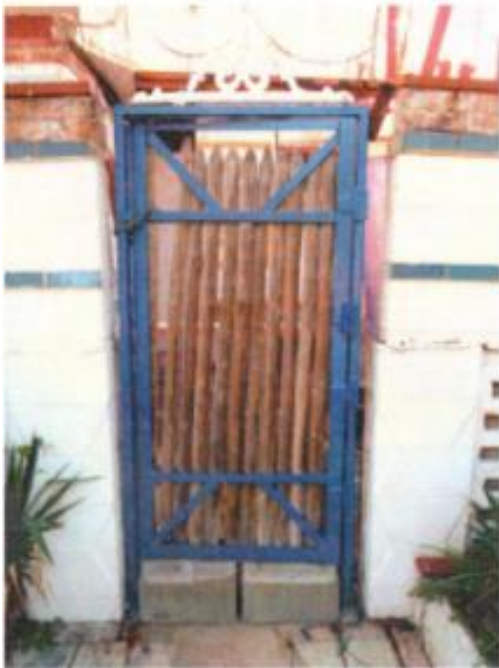
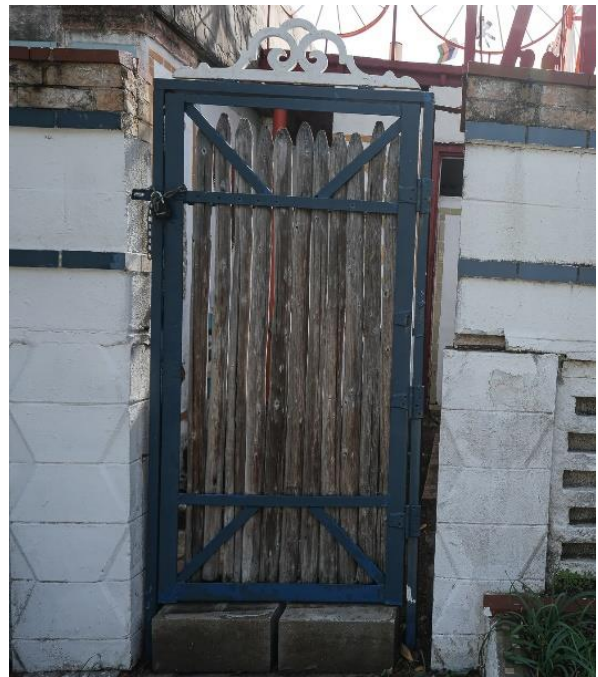
Figure 14. "Damage to an area of the perimeter wall," at the west side. "The wall next to this door frame ...is broken due to foundation movement." Sparks (left 2012, right 2021)

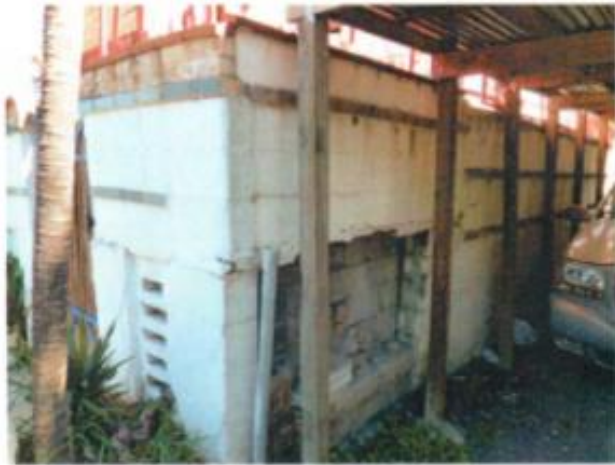
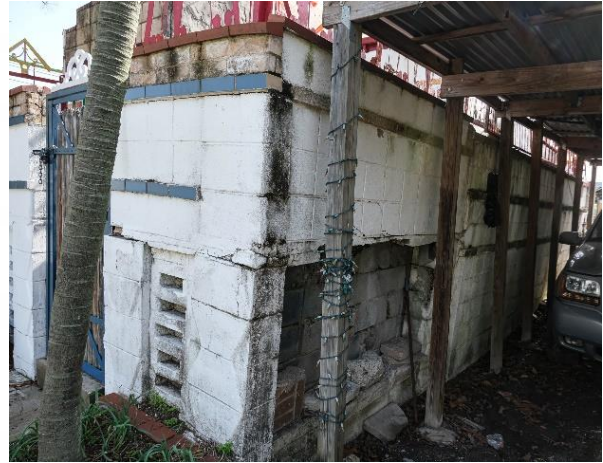
Figure 15. "Extensive cracking and missing masonry. Reconstruction is an option, but also installing vertical reinforcement and grouting would be an appropriate way to strengthen this area." Sparks 2012 (left 2012, right 2021)

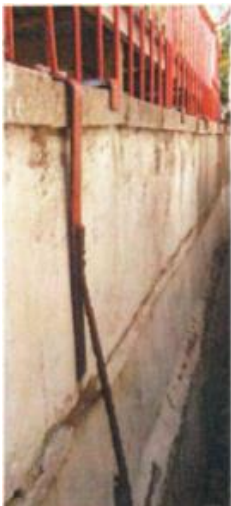
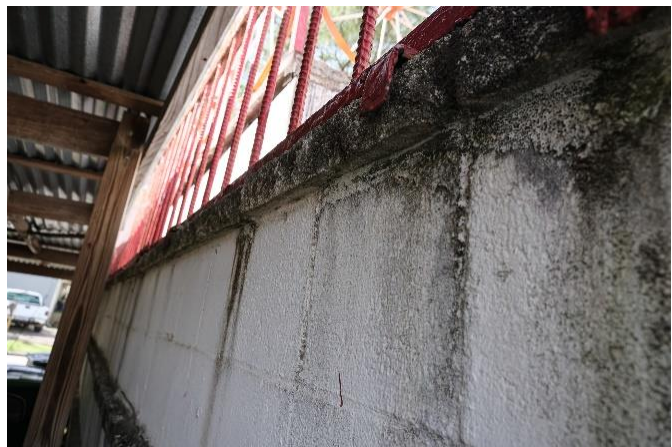
Figure 16. "This exposed tie rod functions to stabilize the wall laterally. It is likely that similar rods were embedded elsewhere inside some of the walls." Sparks 2012 (left 2012, right 2021)

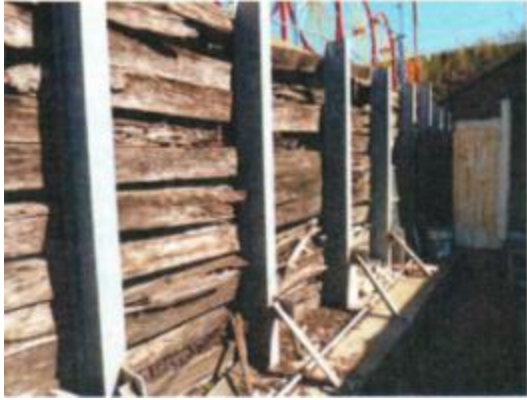
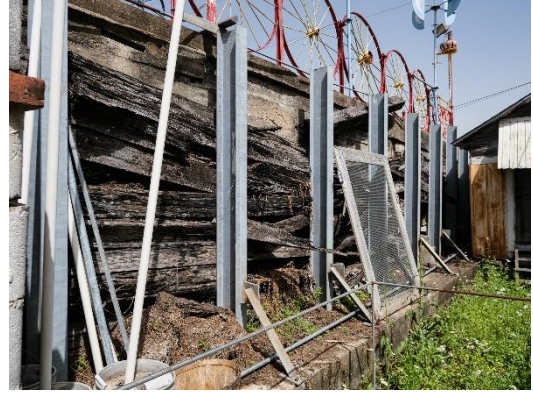
Figure 17. "A steel frame was added during the 1980 repair campaign to help stabilize the south wall. However, the timber lagging has completely decayed." Sparks 2012 (left 2012, right 2021)

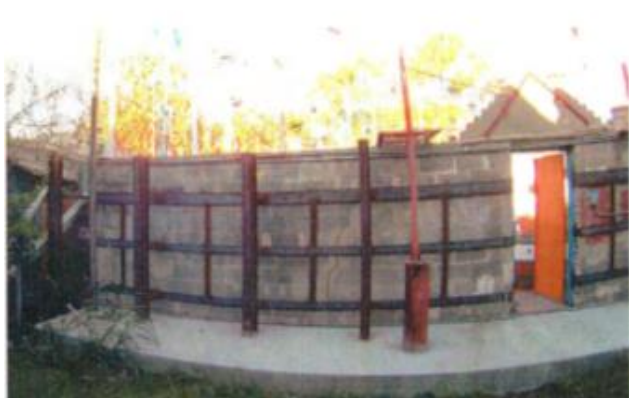
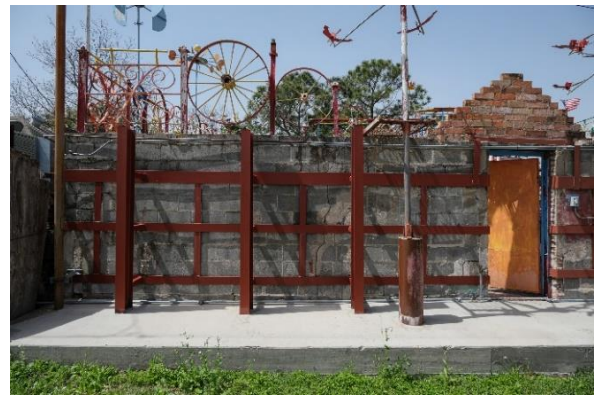
Figure 18. "The east wall has been stabilized laterally by the recent addition (2011) of this steel frame embedded in a concrete strip. This work did not include underpinning. Also, the wall is not tied to the new steel frame." Sparks 2012 (left:2012, right: 2021)

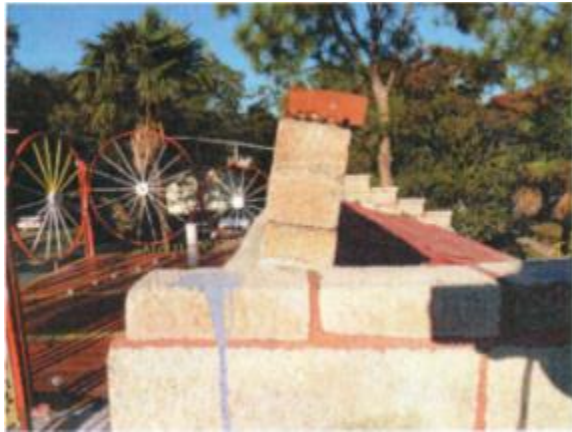
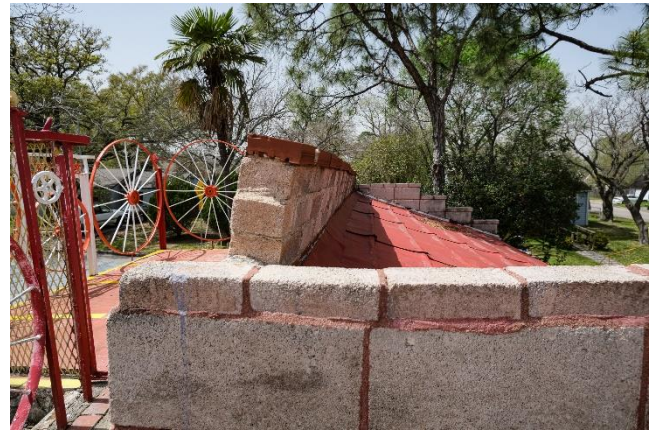
Figure 21. The condition of the parapet over the Side Show stage is an important life safety issue, but does not seem to have moved much since 2012. (left 2012, right 2021)

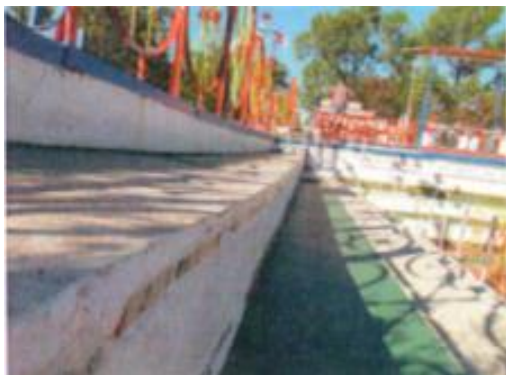
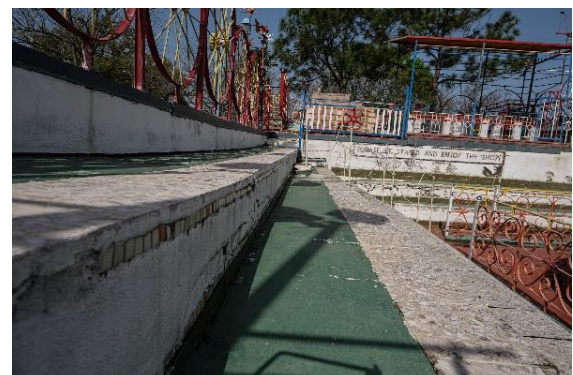
Figure 22. "The Amphitheater seating shows visible sagging and associated cracking, possibly due in part to consolidation of the fill." (left 2012, right 2021)

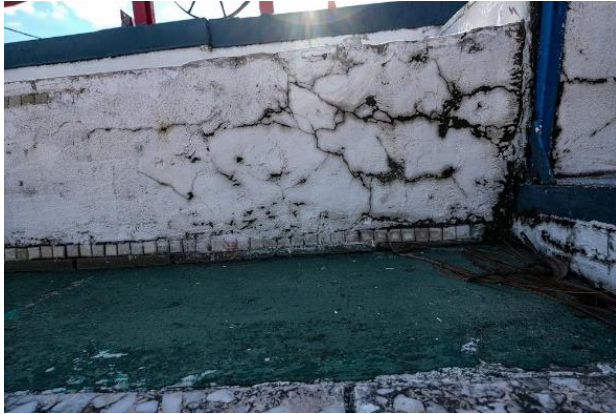
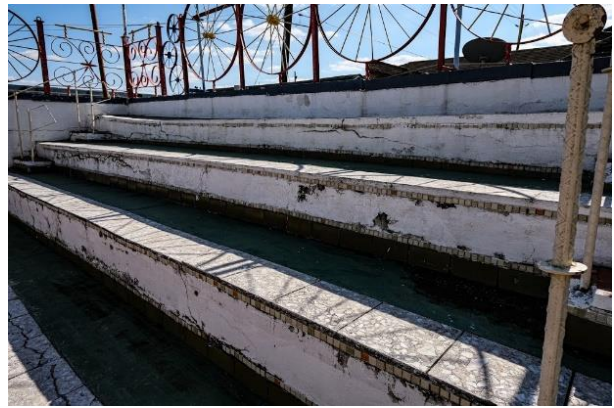
Figure 23. Additional images of the Amphitheater seating.

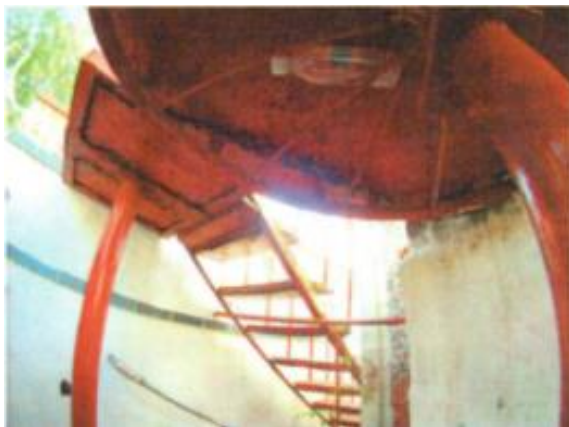
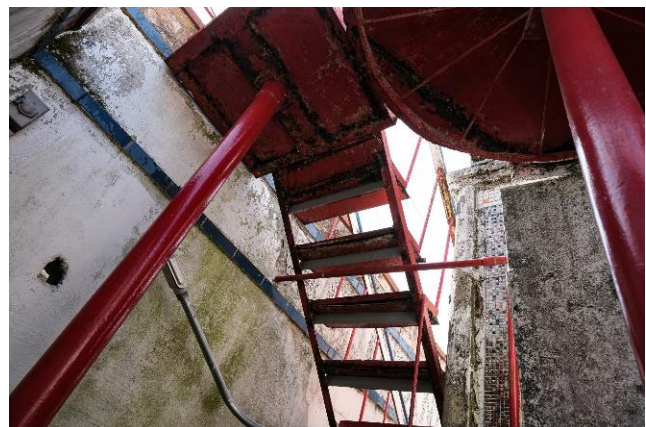
Figure 25. Corrosion at steel stairs (left:2012, right: 2021)

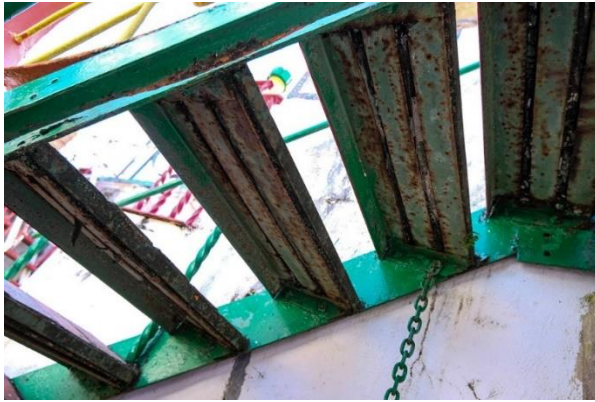
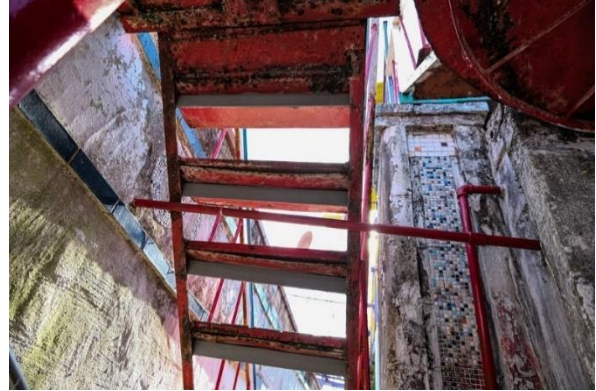
Figure 26. Additional examples of corrosion. These treads will probably have to be removed and recast.

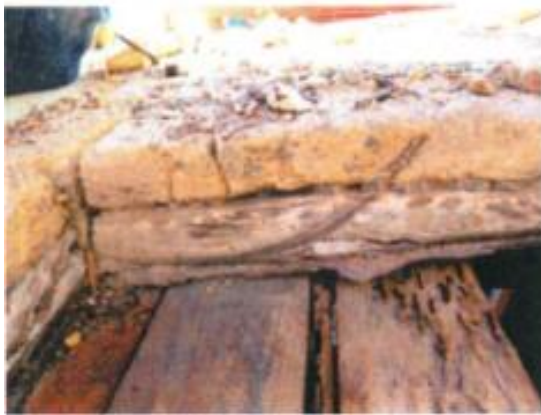
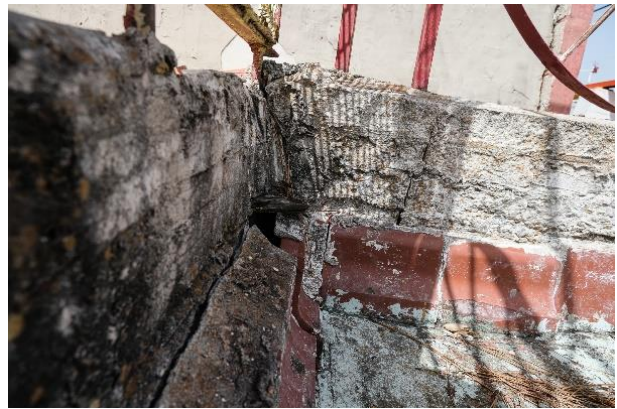
Figure 27. Common conditions at roof decks. (left 2012, right 2021)

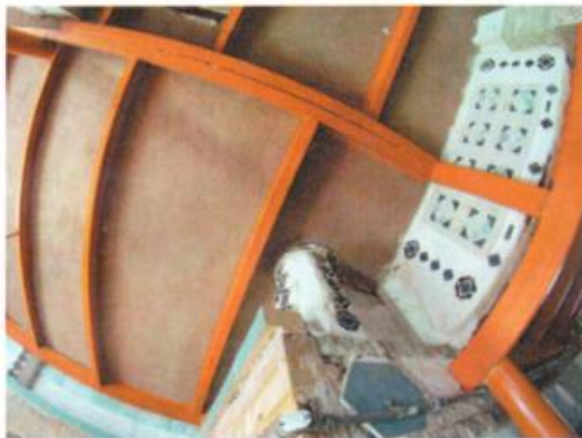
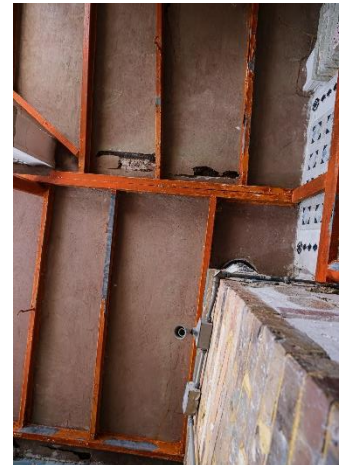
Figure 28. Supplemental steel framing added during in 1980 to improve the safety of the flat roof decks above a passage leading to the men's restroom. Sparks (left:2012, right: 2021)

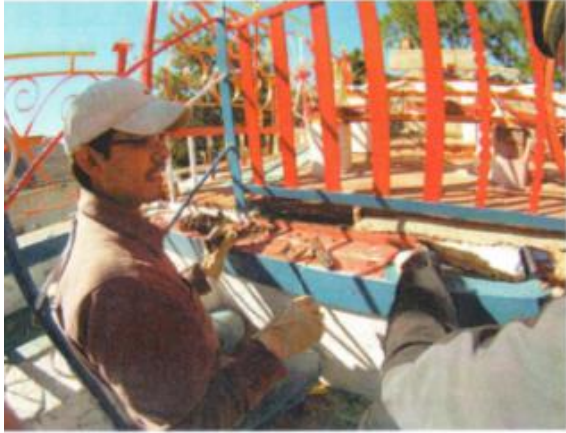
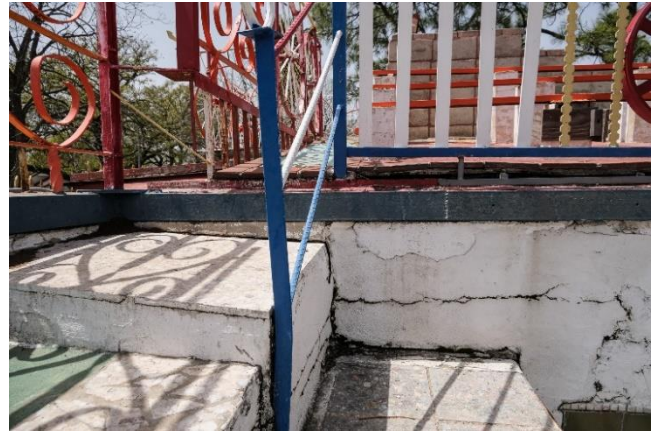
Figure 29. "A probe of one of the observation decks showed the need for an edge flashing to prevent further deterioration." Sparks 2012 (left: 2012, right: 2021)

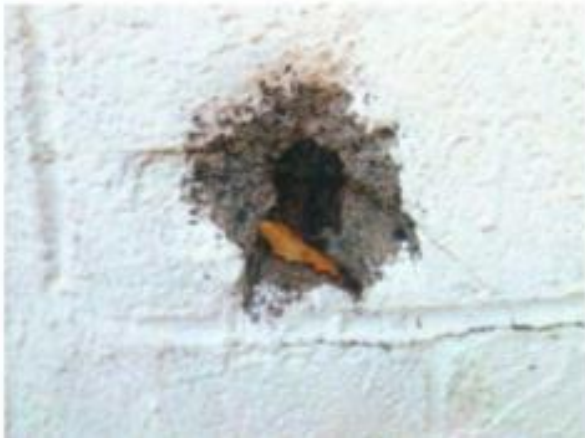
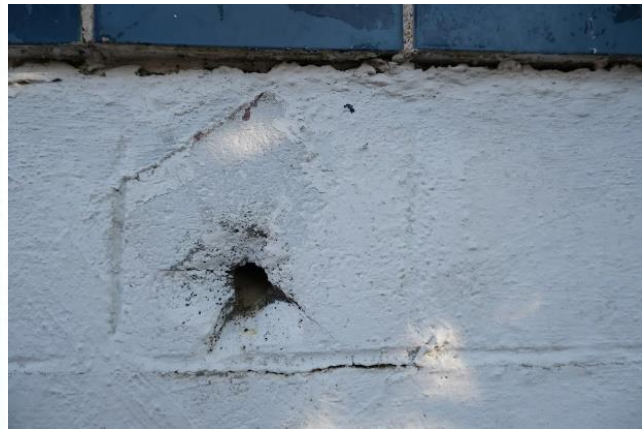
Figure 30. Corrosion example. Embedded tie rod has completely corroded and cracking of the masonry has begun. (left: 2012, right: 2021)

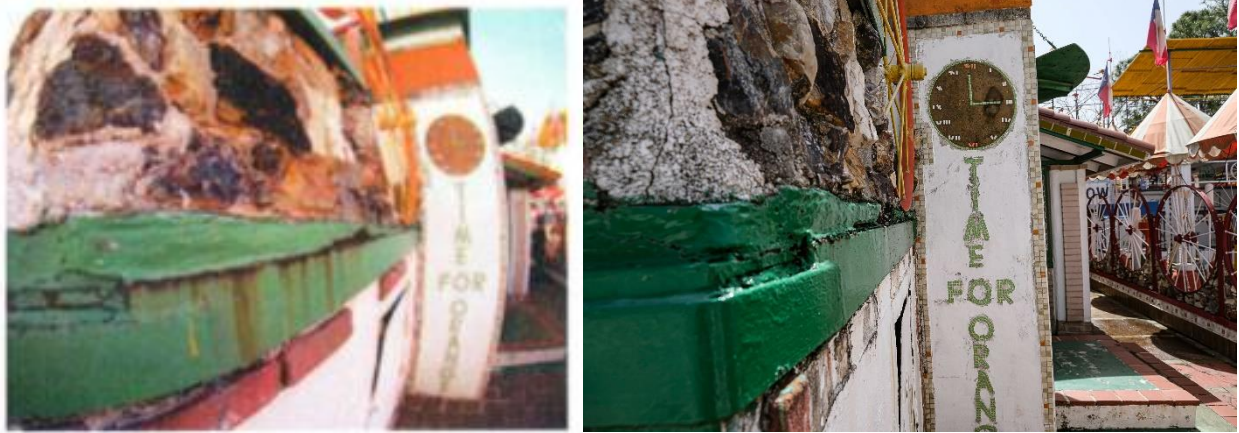
Figure 31. Perimeter framing angle is sandwiched between layers of masonry, promoting corrosion (left:2012, right: 2021).

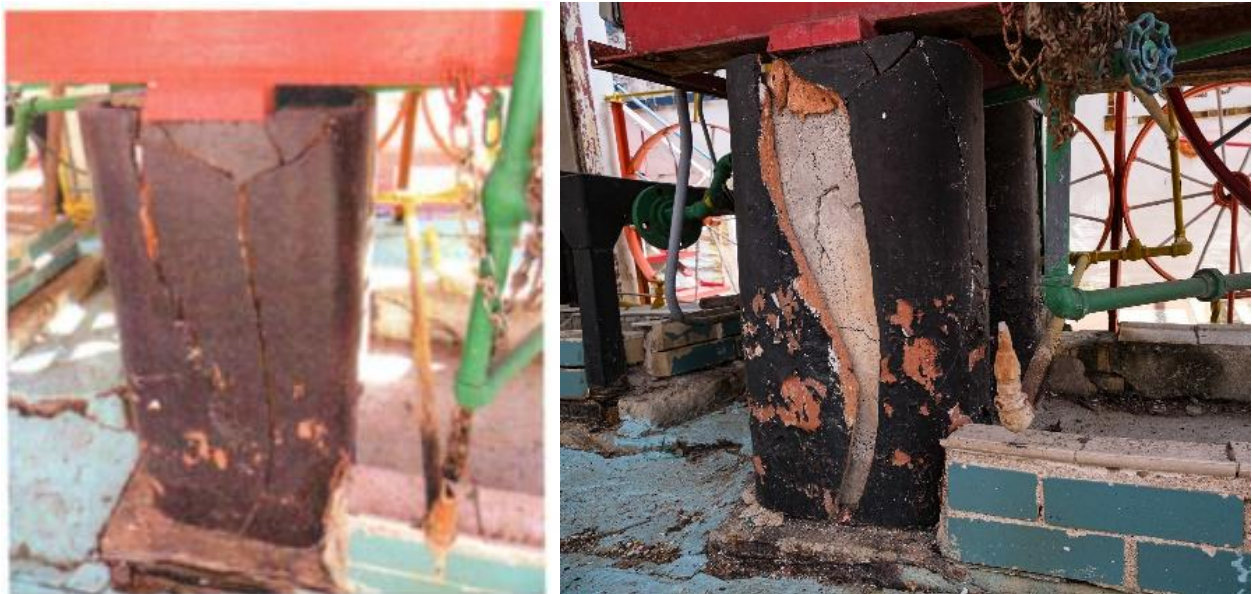
Figure 32. Corrosion expansion cracking a characteristic post-base made of hollow tile and filled with mortar. (left:2012, right: 2021)

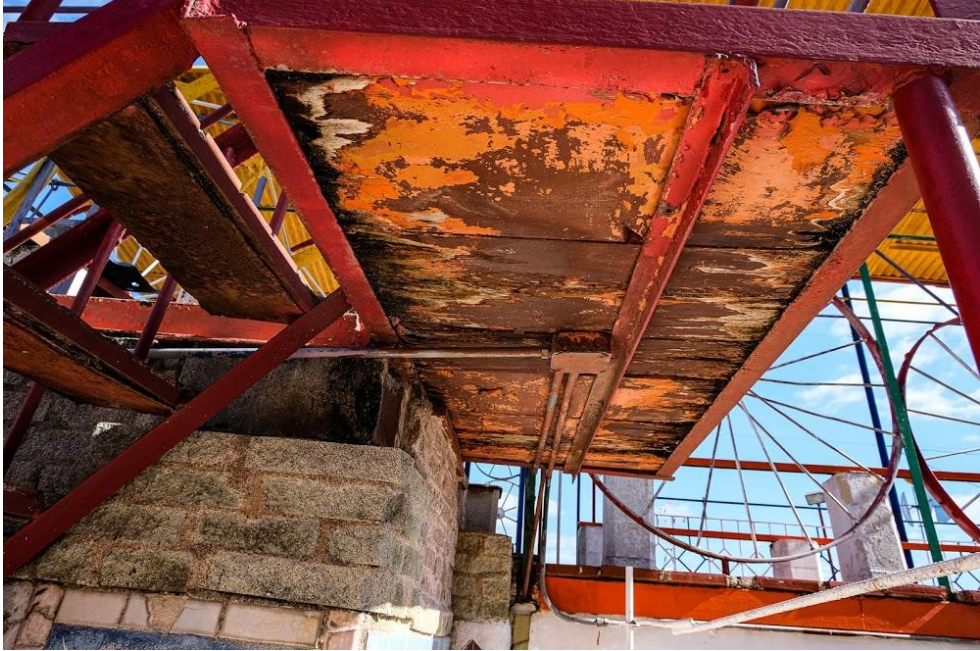
Figure 33. Wood decay and corrosion at the underside of stairs.

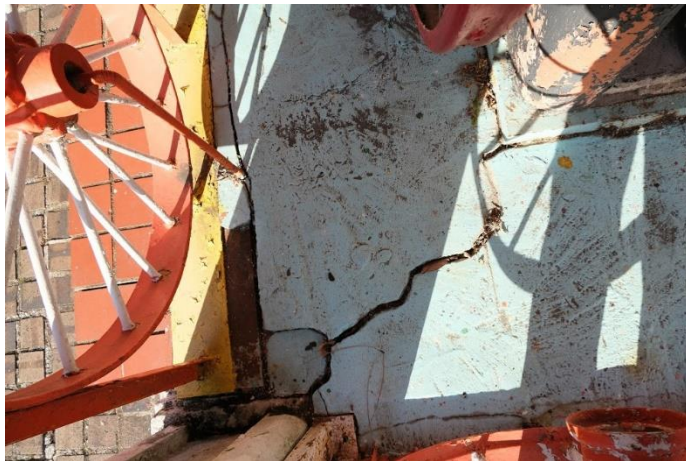
Figure 34. Crack on the observation deck.

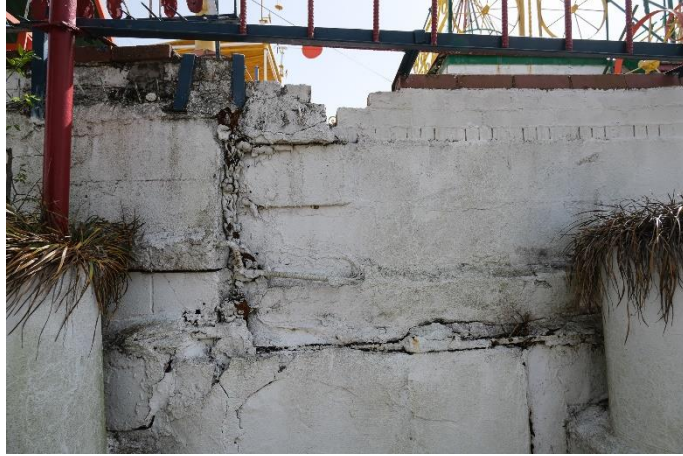
Figure 35. Crack along north exterior wall.

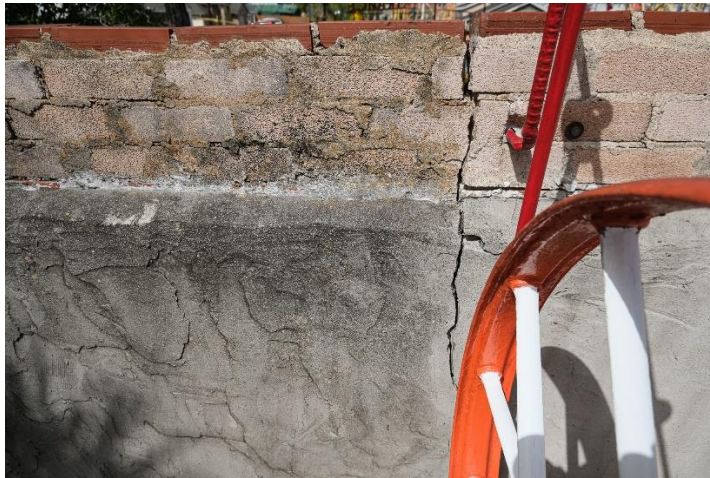
Figure 36. Crack on second floor observation deck behind side stage.

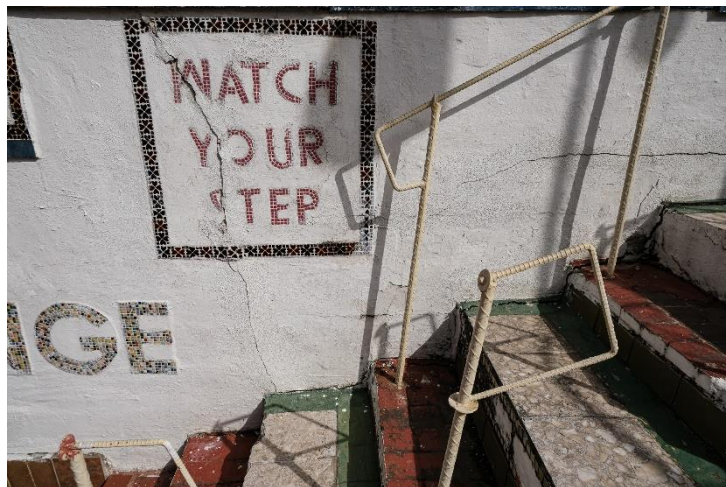
Figure 37. Crack along east wall of Amphitheater seating.

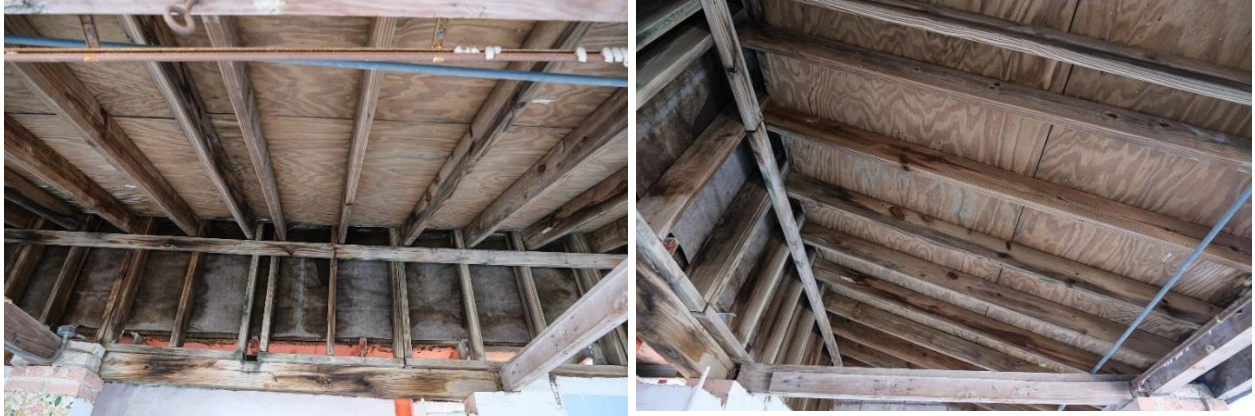
Figure 38. Wood decay at Side Show stage ceiling.

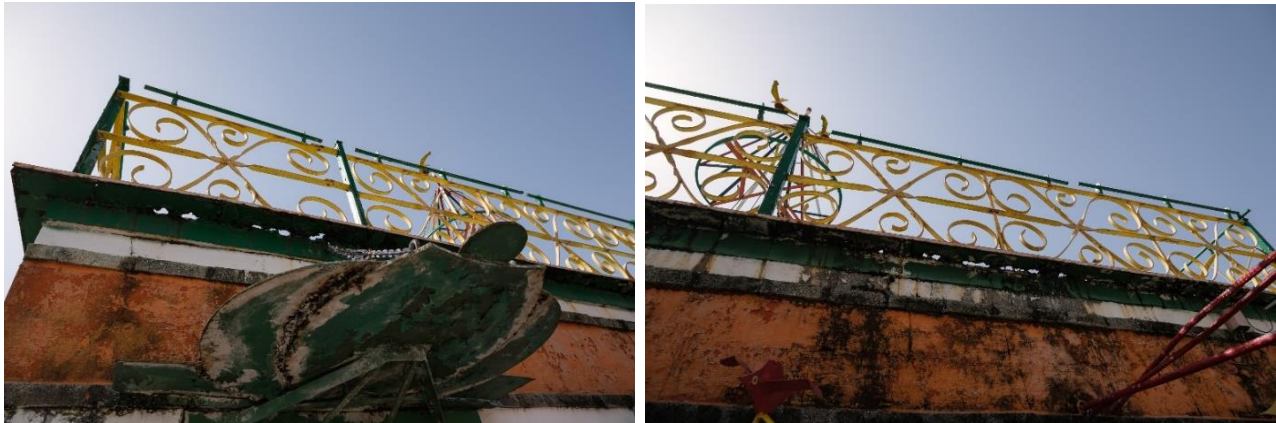
Figure 39. Observation deck showing corrosion in steel at perimeter.
