Treviño-Uribe Rancho Damage Remediation; Preliminary Observations

Treviño-Urbe Rancho Damage Remediation, June 2017.

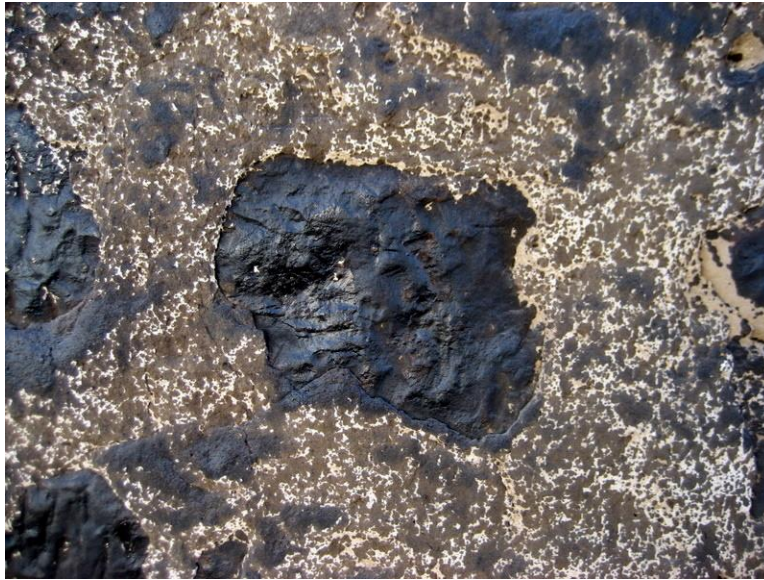
figure 1. typical wall condition following asphaltic application

Approximately 880 square feet of the façade wall area were affected by the recent application of prime coat. In general, the north elevation between one foot and seven feet above the *banqueta* is more than 75% affected with the asphaltic material, while the 12" above and below this section show between about 10 and 75% impact. There are scattered droplets of material along the roofline and on the chimney of Kitchen No.2. Approximately 150 square feet of *banqueta*, stairs, and other horizontal stone surfaces are also impacted, as well as three historic wood doors.

The unfortunate application of the prime coat material to the north façade of the Treviño Fort could have long-lasting negative consequences for both the conservation and the interpretation of this important resource. The MC-30 application should be removed and/or mitigated to the greatest extent possible, using materials and procedures that have been thoroughly tested and proven to be safe and effective – both for the historic building and for those applying it.

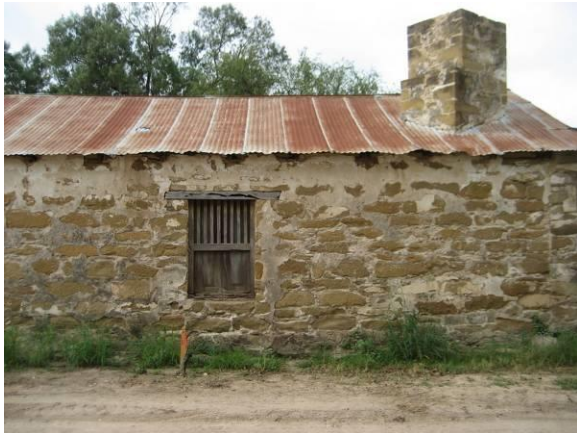
figure 2. N facade, Kitchen #2 July 2009

This and other facades of the complex were repointed and stabilized between spring and autumn 2009. In the course of that work, which included wall base protection through most of the north façade (as well as the east exterior and courtyard facades), limited plaster edge protection and consolidation was carried out. The façade was also documented at that time with high-resolution digital photography.

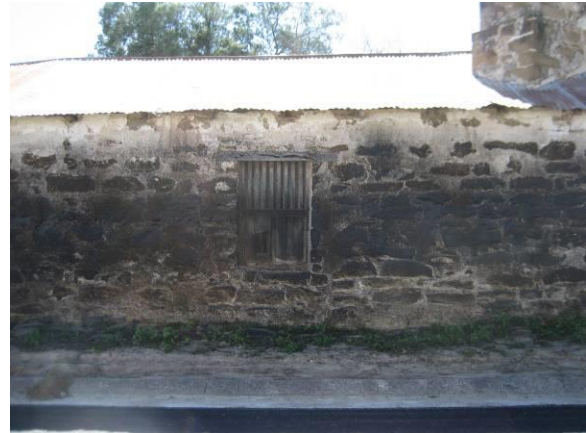
figure 3. N facade, Kitchen #2 January 2010

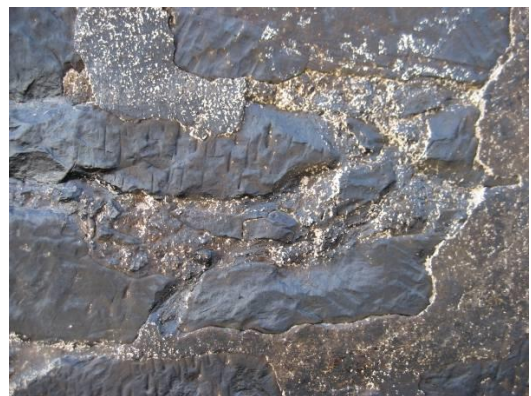
figure 4. typical coverage near wall center

Exposed sandstone in the affected areas shows almost complete coverage while adjacent areas of plaster typically show wide but incomplete coverage. The prime coat material seems to have spread across the surface of the stone in a generally even, very thin coating. Observed

samples found loose along the *banquetas* show a coating less than .1 mm in depth. Plaster samples show a heavier accumulation and deeper penetration, ranging from approximately .2mm – .5mm, but slightly less spreading. This pattern seems to be due to the greater density of the sandstone, and the greater porosity of the plaster.

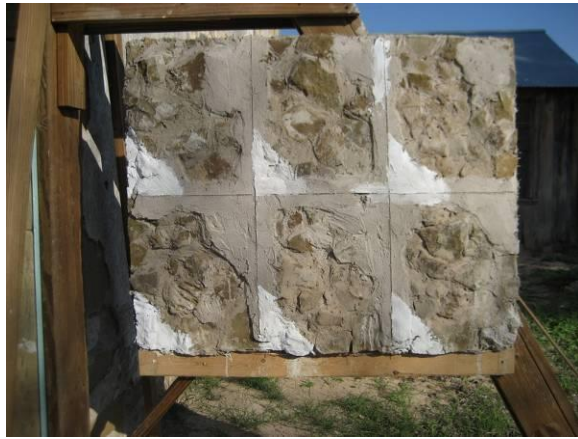
figure 5. test panel before MC-30 application

were built into the panel, anchored and pointed with mortar made from the formula developed as a sympathetic match for the original material. That mortar contains 1 part white Portland cement: 3 parts hydrated chemical lime: 11 parts sand.

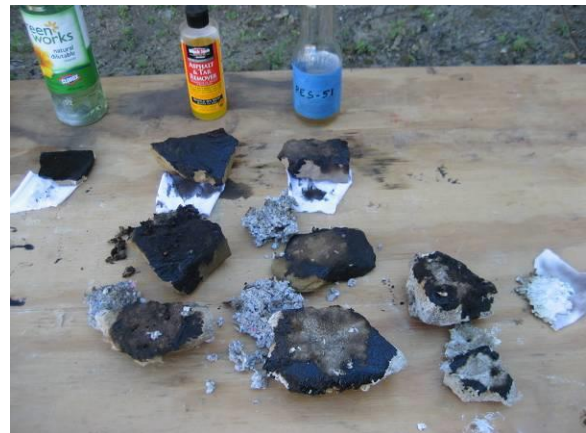
figure 6. spot testing and poultices

Both the PES/lime/cellulose poultice and the PES/cellulose poultice removed the majority of the MC-30 where they had been applied, and in small, limited areas demonstrated the ability to remove more than 95% of the asphaltic coat. The “Black Jack” tar remover tended to spread the asphalt material much more than the PES-51, which is a central concern in the removal process. From this test it was determined that the PES-51 was the most effective of the products spot-tested, and the only of those products immediately at hand bearing further testing for this application.

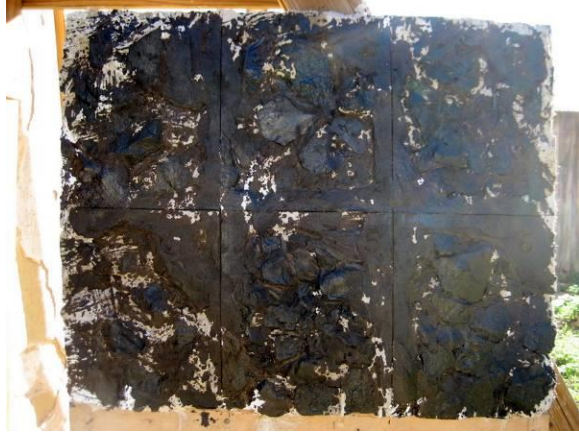
figure 7. test panel with MC-30

On the afternoon of 23 January, MC-30 was applied to the test panel. At this point the plaster and some mortar areas had cured less than 12 hours. The MC-30 was heated to a low boil, and applied to the panel by spattering from about 2' with a 2" China bristle brush until approximately 85% of the surface was covered. At the application temperature, the material is slightly more viscous than water.

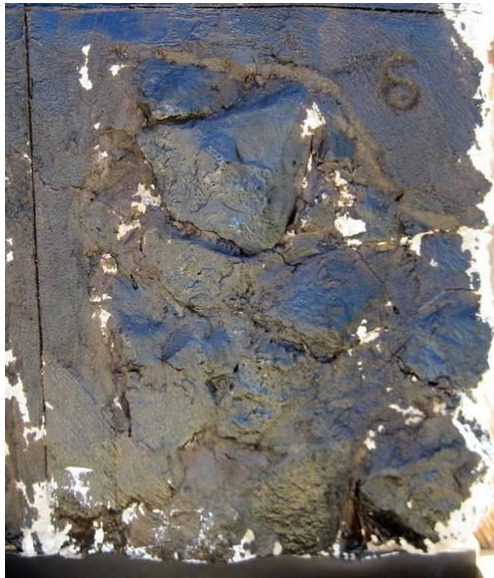
figure 8. sub-panel 6 before PES-51

One day after the test panel was coated with MC-30, PES-51 was applied to the lower right sub-panel, labeled 6. The material was applied by brushing with a 2" China bristle brush until the whole area of panel 6 had been lightly washed,

similar to the amount of material that would be applied with a hand sprayer set to provide a light but constant sprinkling. The MC-30 showed immediate and widespread loosening and apparent emulsification in the PES.

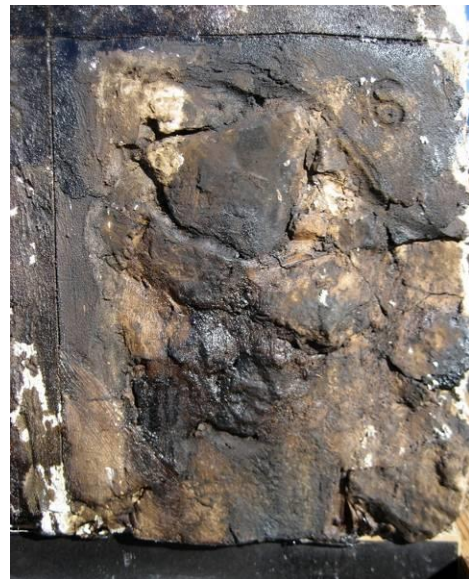
figure 9. panel after PES-51

Although both poultices and the spray rinse were completed within 5 minutes of the maximum dwell time recommended, it seemed that the product's effectiveness decreased rapidly following the initial application. A film formed over the surface within about 5 minutes, and subsequent rinse water beaded on the surface. Additional applications of the PES were not carried out at that time.

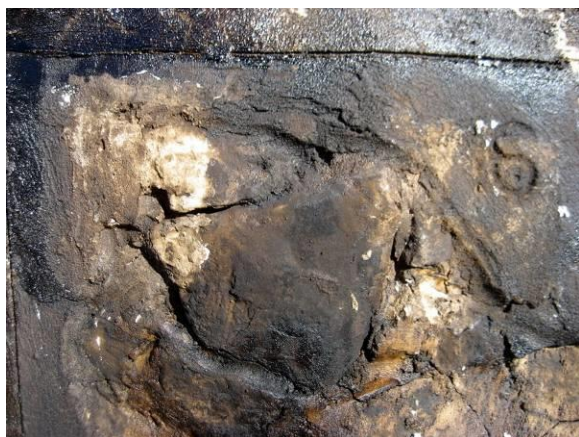
figure 10. detail of areas of poultices

When the poultices had thoroughly dried - about 5 hours after application - they were carefully removed from the test panel. Both poultices came off in generally large, cohesive pieces, without removing any of the panel stone or plaster surface with them. Results similar to those obtained with the poultices applied to the separate stones were repeated here, even though these poultices were bound principally with water rather than additional PES.

A clear pattern of removal was evident where both poultices were applied, although within each pattern there was considerable variation in the degree to which the MC-30 was removed. Some areas treated with a poultice show a minimum effect, while others show almost complete removal of the MC-30. A less conspicuous pattern exists on the lower half of the test area, which received only a water wash following the application of the PES.

The effectiveness of the PES applications, both with and without poultices, seems heavily influenced by the timing and rate of the product's evaporation. The first PES-treated areas to come in contact with a rinse of any kind were the poultices, and the most complete removal within those areas was where the poultice was applied first. This sequence of events probably delayed the formation of the protein film and allowed more thorough emulsification of the MC-30.

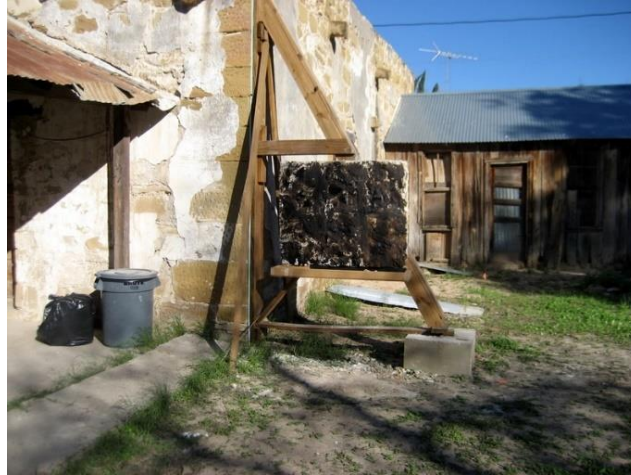
figure 11. test panel in Fort courtyard
