## A Report on Conditions and Monitoring at the J.K. Williams Flagpole and Monument

In July 2015 Frank Briscoe with Briscoe Architectural Conservation (BAC) participated in a study of conditions at the flagpole and monument immediately east of the J.K. Williams building.

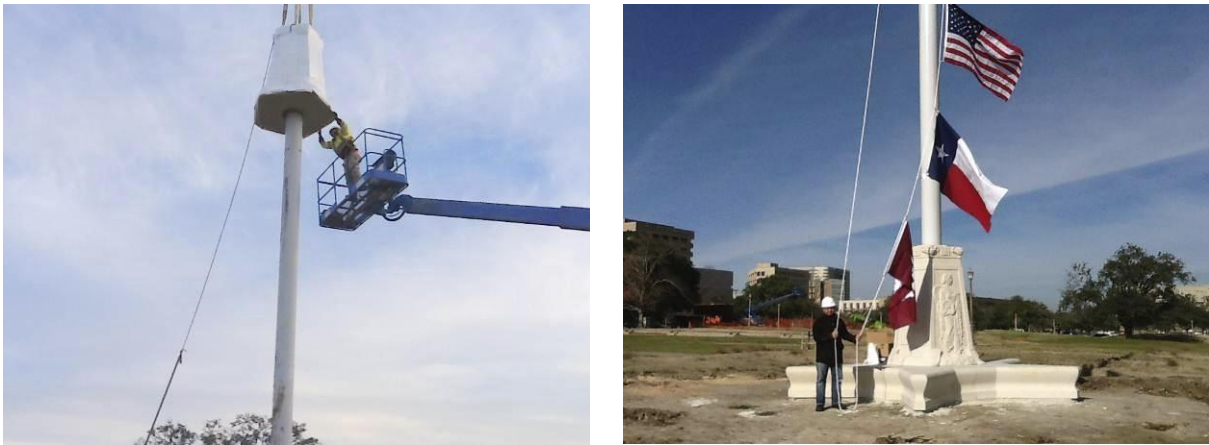
Monument being installed in January 2015, and flying its first flags a few days later. While the precise cause or causes of the fractures still cannot be identified with certainty, the character of the fractures and the times they appeared are consistent with specific weather events. In particular, the appearance and extension of fractures correlates with high wind and rain following the installation of the monument in January, and year-to-date high winds in August. Weather both of these dates included at least one inch of rain.

The likelihood is very high that the recent, perhaps irremediable, increase in fractures are due to a combination of high winds, wet porous flags, thick backer rod, and an offset mortise. In the opinion of the consultant, while the existing monument could be modified to reduce further damage from identified causes of fractures, the damage already done may make repairs aesthetically unsatisfactory, ineffective, and/or cost-prohibitive.

If the existing monument is to be replaced, much can still be learned from it before it is disassembled. Among the adjustments that could help assure the integrity of the next replica are: removing the backer rod, installing a venting collar, monitoring interior humidity and weather data, and continuing the photographic monitoring program.

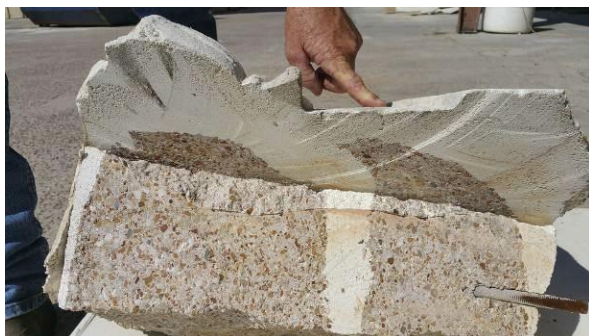
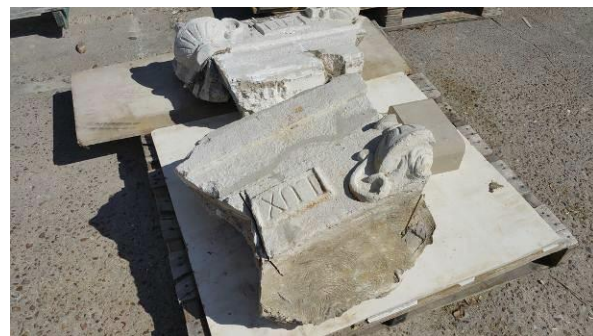
The consultant visited Stone Castle Industries on 13 October 2015 to see pieces of the original monument and to gather information about rebar placement in the existing monument. Many pieces of the original are still on site there, and show what looks like a two–part construction technique. It appears that the dolomitic surface referred to in the McCoy report of 2012 was packed into the mold before a much grainier mix with +/- 0” aggregate was either poured or packed in behind it. The original pieces that were inspected contain very little reinforcement bar.

Pieces of the original cast stone monument designed by Hugo Villa, being stored by Stone Castle.
