Historic Resources Assessment  
Rancho La Union, Zapata County, Texas

for the Guadalupe and Lila Martinez Foundation

FRANK BRISCOE / Architectural Conservation

December 2009

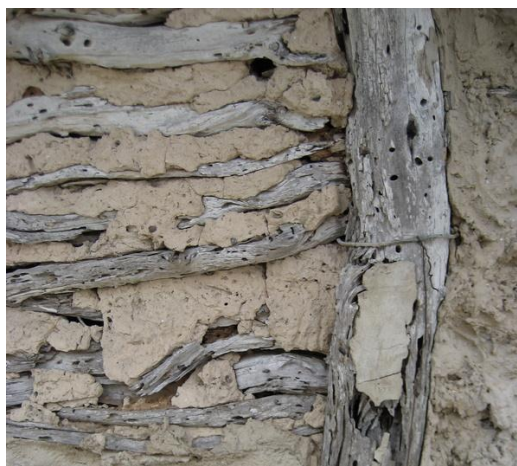
Walls are traditional *jaca* construction, with pairs of rough posts lashed together to support an infill of split mesquite material covered with earth plaster (fig.8). Roof framing includes dimensional material as well as hand hewn elements. The original thatched roof is visible below the later corrugated iron roof. Fasteners used in the building range from hand-made pegs to cut nails and extruded nails. Cut nails, which were clipped from an iron bar, were widely replaced by the modern extruded nail by

figure 8. typical Bunkhouse exterior wall construction

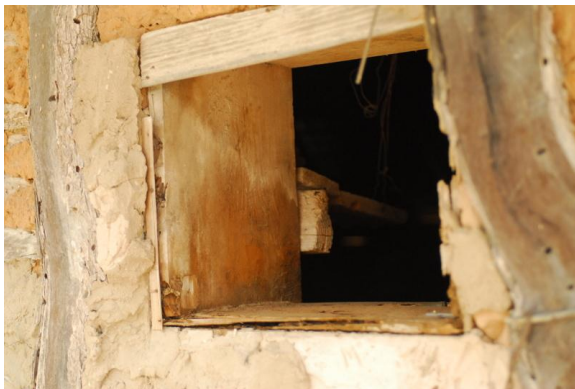
figure 9. crate used as interior shelving (not window)

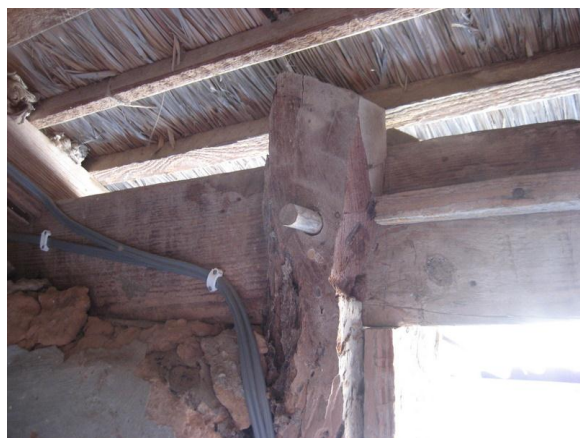
figure 13. pegged connection of plate to posts at doorways

At the north and south walls the posts support a 3x5 pine or cypress plate/beam generally 73 to 74" above the slab. At the west wall, which has been largely rebuilt, the beam is a pair of 2x6s. At the north and south doors the openings are framed with rough mesquite members finished with an adze and notched to receive the plate in a kind of saddle joint. At doorways the plates are fastened into place with hand-carved round wood pegs about 3/4" in diameter (fig.13).

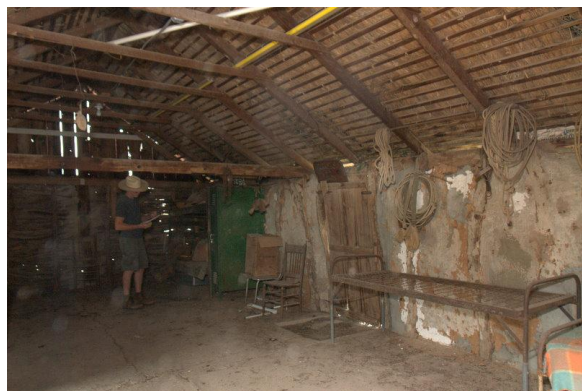
figure 17. Bunkhouse interior looking northwest

suggesting they may have been reused from another installation. Collar ties stiffen the rafters. These are 1" by 3", and are located 103 1/2" above the floor (fig.17).

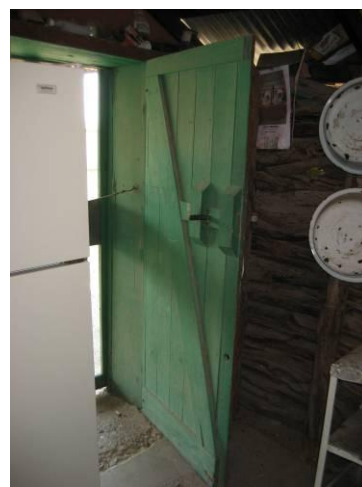
The kitchen has one door, on the east wall near the southeast corner (fig.22).

figure 22. plank door with wood latch

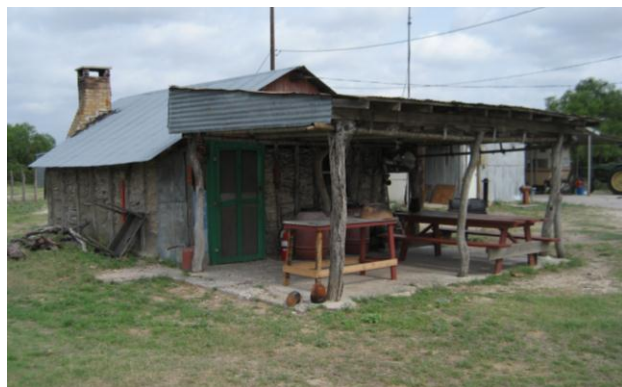
figure 23. Kitchen, east façade, with porch

Adjacent to the east wall, the kitchen has a shed roofed porch with a corrugated covering (fig.23).

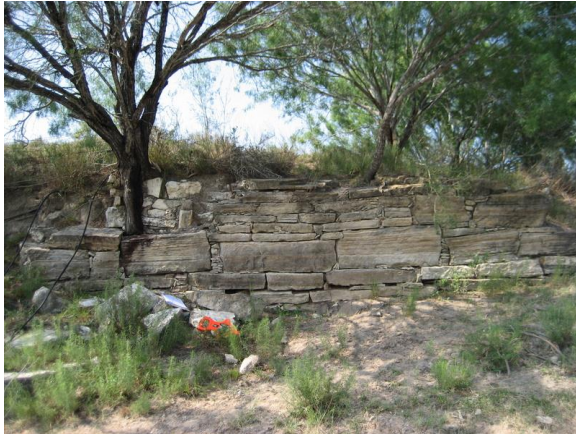
The stone dam is an impressive structure just east of the center of the site (figs.24,25). It is about 360' long and runs in a straight line generally east-west. The masonry face of the dam is approximately 30" thick, finished on the outside only, and is built into a berm or earth levee behind it. In sections near the west end of the dam, the masonry wall is more than 7'6" high.

figure 24. section of the stone dam near the west end

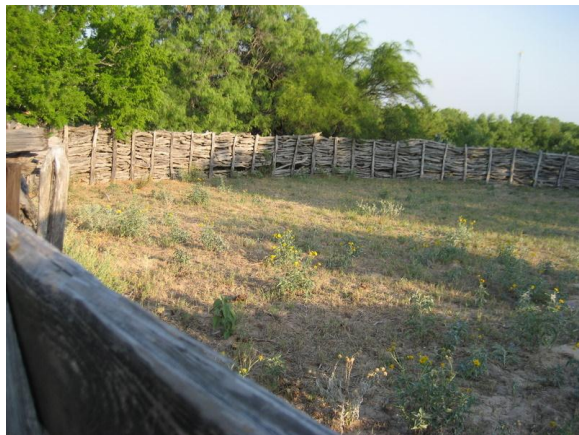
Rancho La Union has approximately 1,250 linear feet of mesquite / cedar post fencing (figs.26, 27). Fences are about 5' high, built of pairs of 3-1/2" to 4" diameter cedar posts with a stacked infill of split mesquite branches. Pairs of posts are set on +/- 32" centers with the individual members of the pair spaced about 12" apart on center (drwg.E).

figure 26. mesquite corrals west of complex, typical

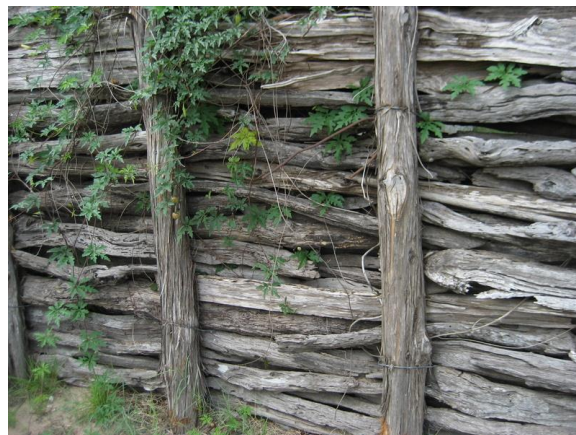
figure 27. cedar posts with mesquite infill, typical

Mesquite infill varies in diameter, with some members up to 4" (fig.). Lengths typically extend a few inches on either side of the pairs of posts. Gates at openings between the fence sections are hung on posts detached from the fence. Most are creosoted 6" round posts or railroad ties. Gates vary widely in size and construction, and are generally later features.
